THE DEVELOPMENT OF MOULD GROWTH IN A FABRIC STRUCTURE
IDENTIFICATION OF SOURCE AND CONTROL MEASURES

CASE STUDY : L. THOROGOOD

Floreat Forum Shopping Centre is a suburban centre located north of the city of Perth. The centre was constructed in the mid-1960's.

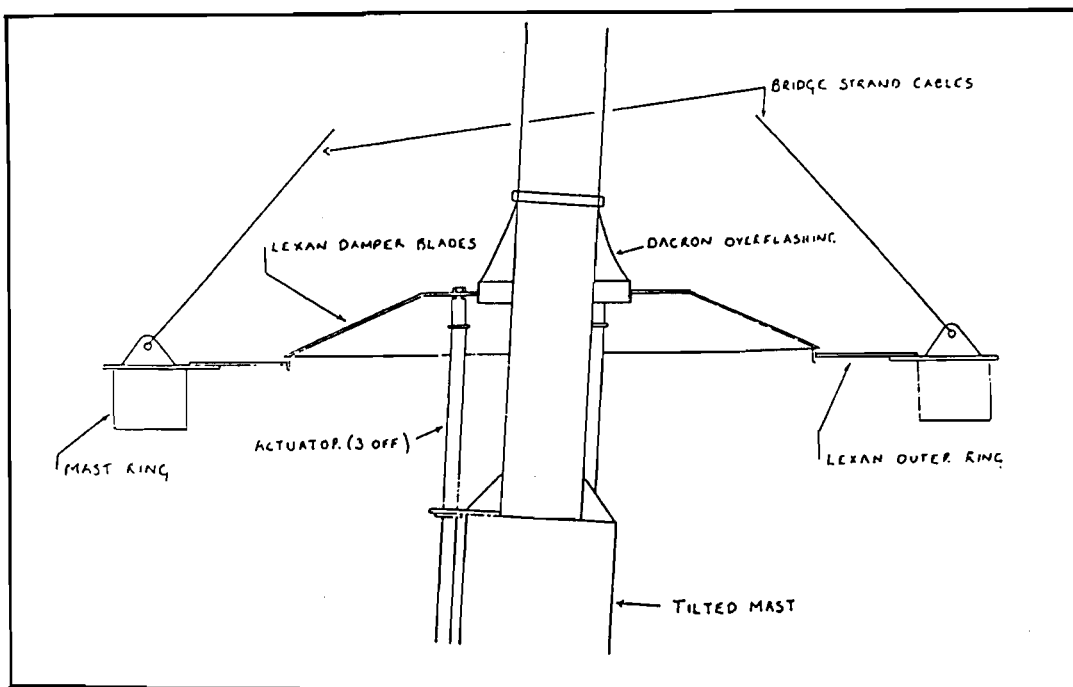
FLOREAT FORUM
MAST VENT DETAIL

The consultant designed a flat acrylic cap to each of the steel rings for weather protection. The acrylic caps were originally conceived as being capable of automatic operation in conjunction with rain sensors. The principle of the design of the vents was that they would be open in summer months to allow natural venting of radiant heat by stratification. In winter months the vents would be closed to reduce loss of heat.

It was also revealed that the design of the vents was providing difficulties:

- . The 1.8mØ acrylic discs were not sufficiently reinforced and 'fluttered' in moderate wind.
- . The vents frequently jammed as a result of the inclined mast angle relative to the horizontal plane of the mast ring and vent cap.

1. A flexible membrane be attached to the outside of the Western side of the truss to prevent ingress of mist from parklands.
2. Fixed cones with permanent venting capacity be attached to each top ring and the original vents removed.
