THE PERFORMANCE OF NINE FABRIC STRUCTURES

IN AUSTRALIA OVER THE LAST DECADE

MSAA/LSAA Conf Proceedings

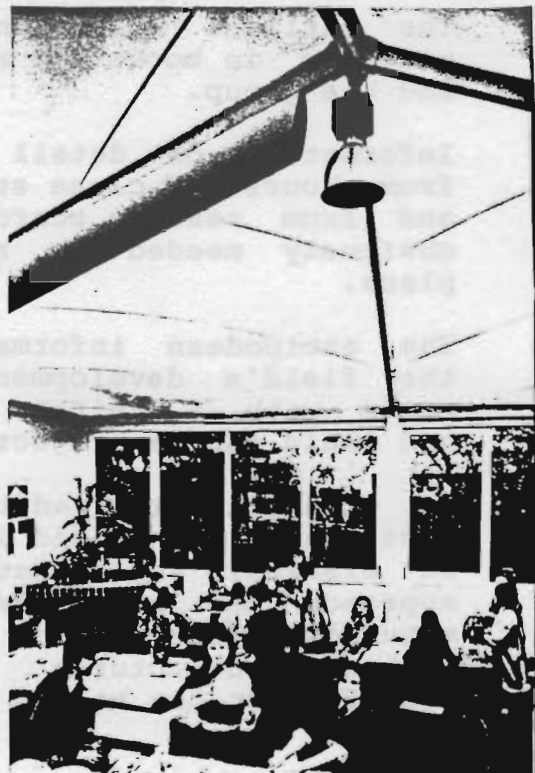
PROJECT: Art house roof
CLIENT: Ivanhoe Girls' Grammar School, Victoria

MAINTENANCE: Cleaned every 12-18 months. One pin-hole puncture about 5 years ago, otherwise, no leaks or problems.

CONDITION: The structure exhibits good surface appearance and is apparently of a similar translucency to that when new. It is still white. The PVC surface has degraded to expose fibres at weld lines and the surface is somewhat brittle.

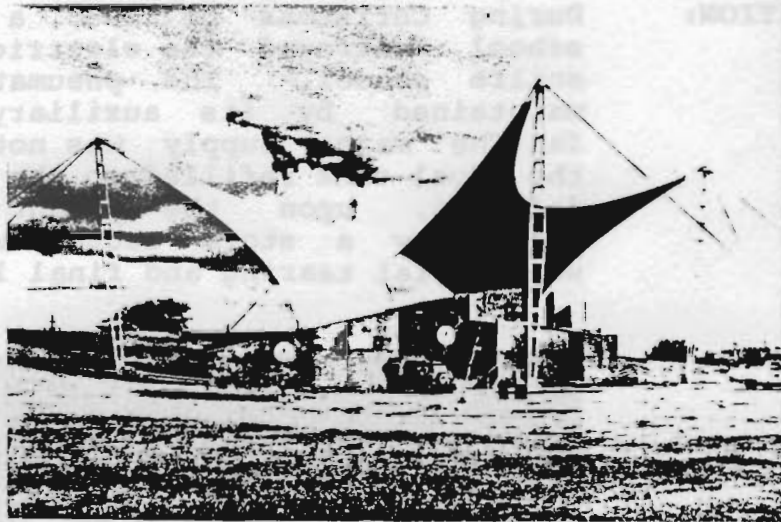
PROJECT: Dean Park Sound Stage Roof
CLIENT: Council of the city of Townsville, Queensland

MAINTENANCE: Cleaned annually in March
CONDITION: From ground level the fabric appears as good as the day it was built - no deleterious effects.

*Kondensation problem!
in humid environments*

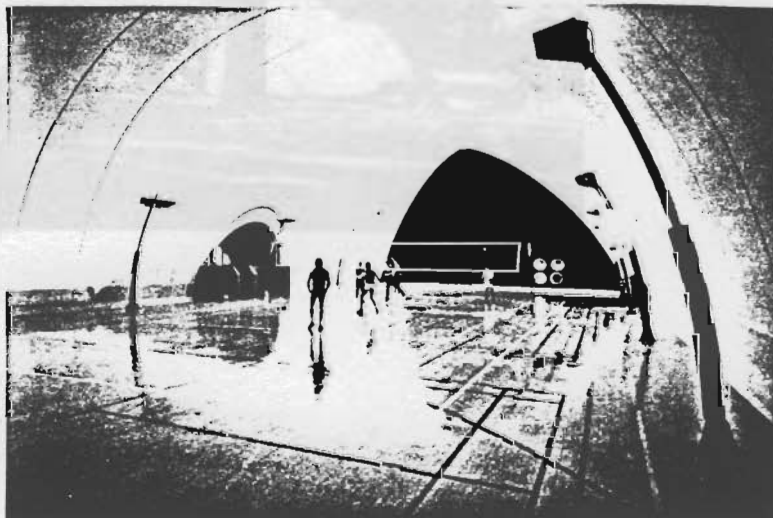
PROJECT: Sports hall pneumatic roof
CLIENT: Melbourne University Sports Union, Victoria

MAINTENANCE: A series of minor vandalism incidents required repair works. Surface cleaned once.

CONDITION: The structure was severely damaged after a person exited the structure through an emergency exit (breaking the glass over the door release handle) causing depressurization during a severe storm. Early in the morning, staff were warned by an alarm system which registered the loss of pressure. However the membrane was torn in several places as a result of contact with light supports and repressurization was not possible when staff arrived at the building. The damage to the membrane was severe, resulting in total loss.

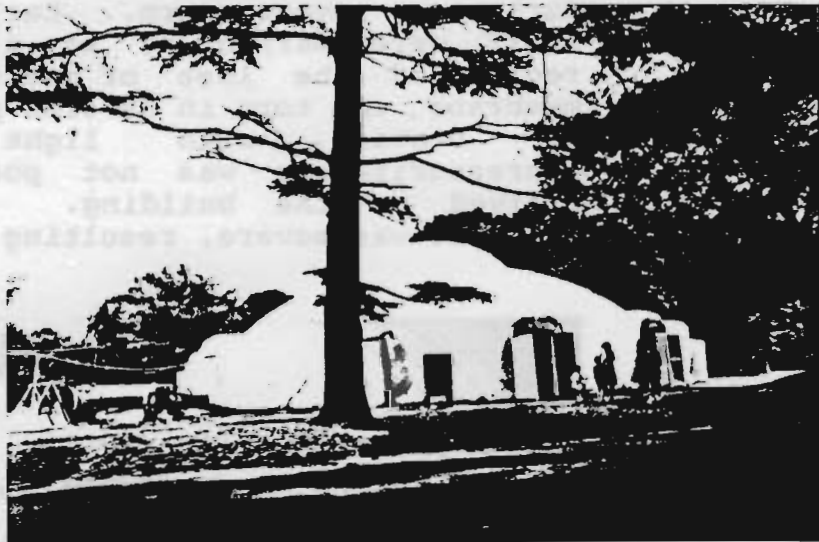
PROJECT: Pair of pneumatic structures for touring performance group.
CLIENT: Command Performances, Sydney N.S.W.
ARCHITECTS: In-house design
ENGINEERS: Peter Kneen Pty. Ltd.
FABRIC: Polymar PVC/Polyester Type II with carbon black substrate
COMPLETION: December 1980

MAINTENANCE: Ground anchor replacement, door repairs and significant cleaning and mould removal program. Some vandalism rectification.

CONDITION: After a successful life of six years, the company ceased using the structures - current status not known.

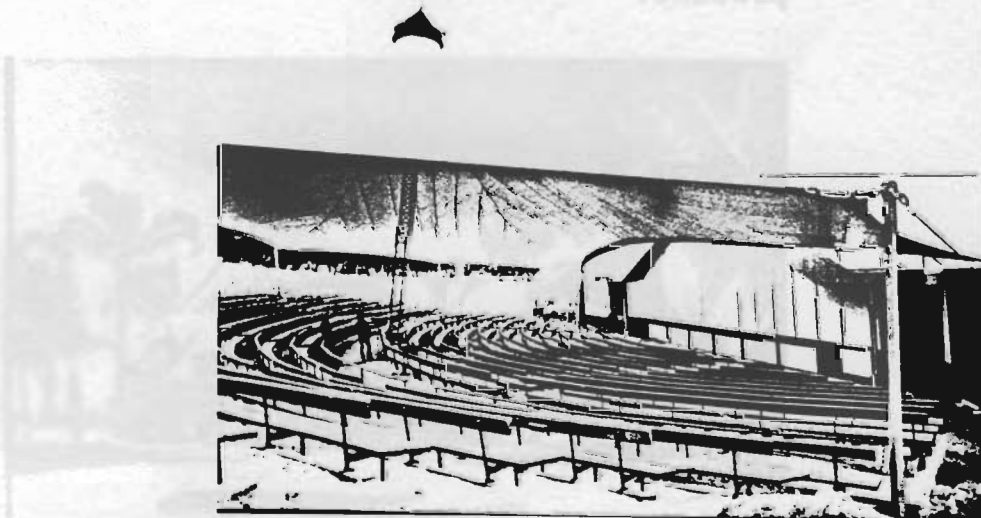
PROJECT: Amphitheatre roof
CLIENT: Seven Creeks Run Trust, Euroa, Victoria

MAINTENANCE: Since the venue has been closed for much of its life, the structure has not been maintained.

CONDITION: The surface is soiled from dust (it is in a rural setting), but otherwise performing well. No other problems are known.

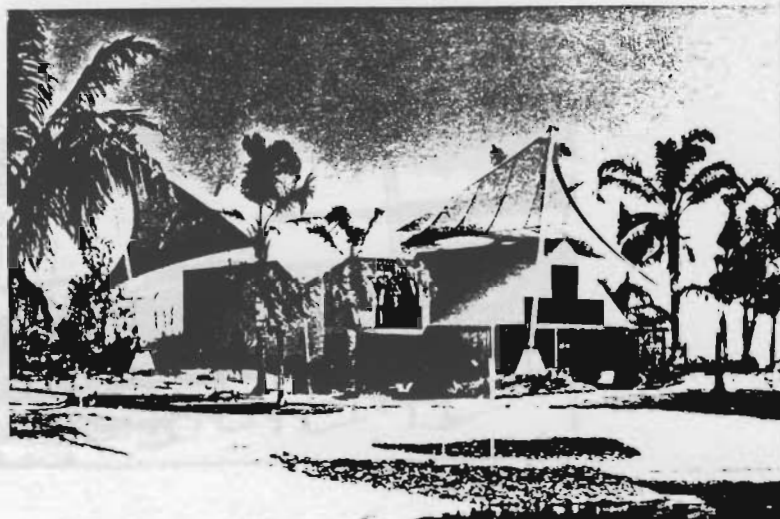
PROJECT: Temporary structure over display apartments
CLIENT: Lend Lease, Queensland.

MAINTENANCE: Nil
CONDITION: The structure is located in an area where seasonal cane field burn off causes a big deposition of carbon material and the region has been the centre of large scale earth moving activity. As the structure has never been cleaned it is very dirty, but is still in place though not used to shelter display units at present.

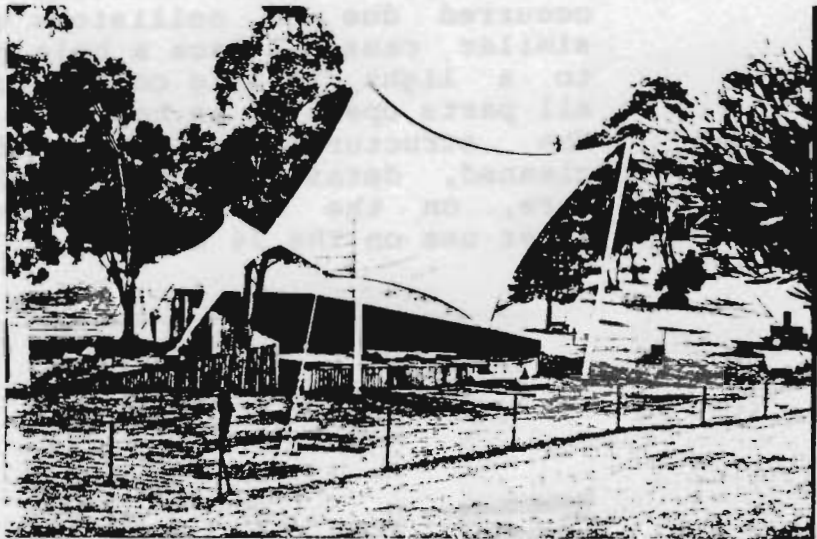
PROJECT: Sound stage roof, Tolosa Street Reserve
CLIENT: Shire of Glenorchy, Tasmania

MAINTENANCE: Has not been cleaned as yet - left to the elements.

CONDITION: Looks good. No deterioration.
