The Development of a Small Market

A Fabricators View

by **Mike Ure**
Structurflex
Auckland
NEW ZEALAND

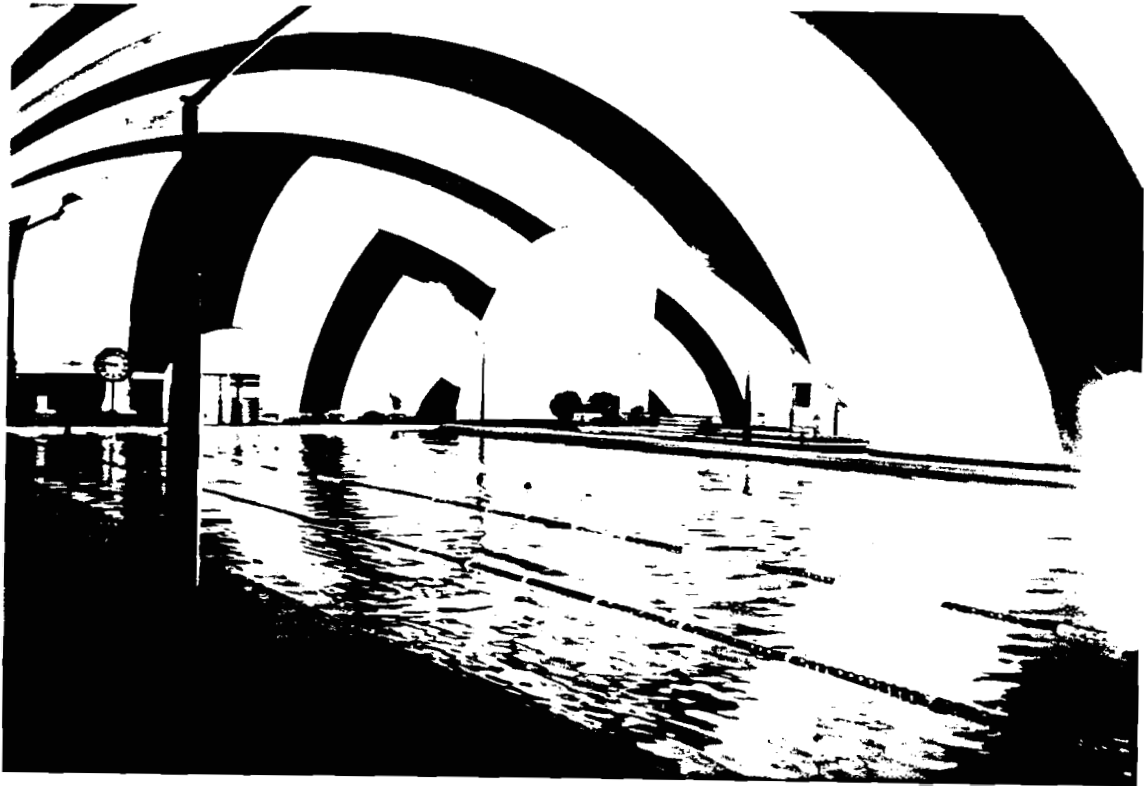
MASSEY PARK POOL DOME

Firstly the Massey Park Pool Dome. The Papakura City Council wished to build a removable coverover their Olympic sized pool but also to cover a learners pool within the same enclosure. The result was an 'L' shaped structure formed by pushing an 11m x 24m bubble against the main 56m x 24m structure. A valley cable relieves the fabric at the junction of the two domes. Connel Barrow and McCready Pty were the specialist consultants and we understand they found the form finding "interesting". The mechanicals were designed by Babbage & Partners retained directly by the City.

The dome is performing all of the functions required of it, but it is a laborious job to erect and remove. I understand some of the new air houses have addressed this problem and have 'hold down and jointing' systems that are less labour intensive.

The dark colours, cream and green, make the dome quite hot on sunny days and we would suggest that future domes be predominatly white with coloured highlights only.

Noise reverberation is a problem when school sports events are held.
