THE DEVELOPMENT OF MOULD GROWTH IN A FABRIC STRUCTURE
IDENTIFICATION OF SOURCE AND CONTROL MEASURES

CASE STUDY : L. THOROGOOD

Floreat Forum Shopping Centre is a suburban centre located north of the city of Perth. The centre was constructed in the mid-1960's.

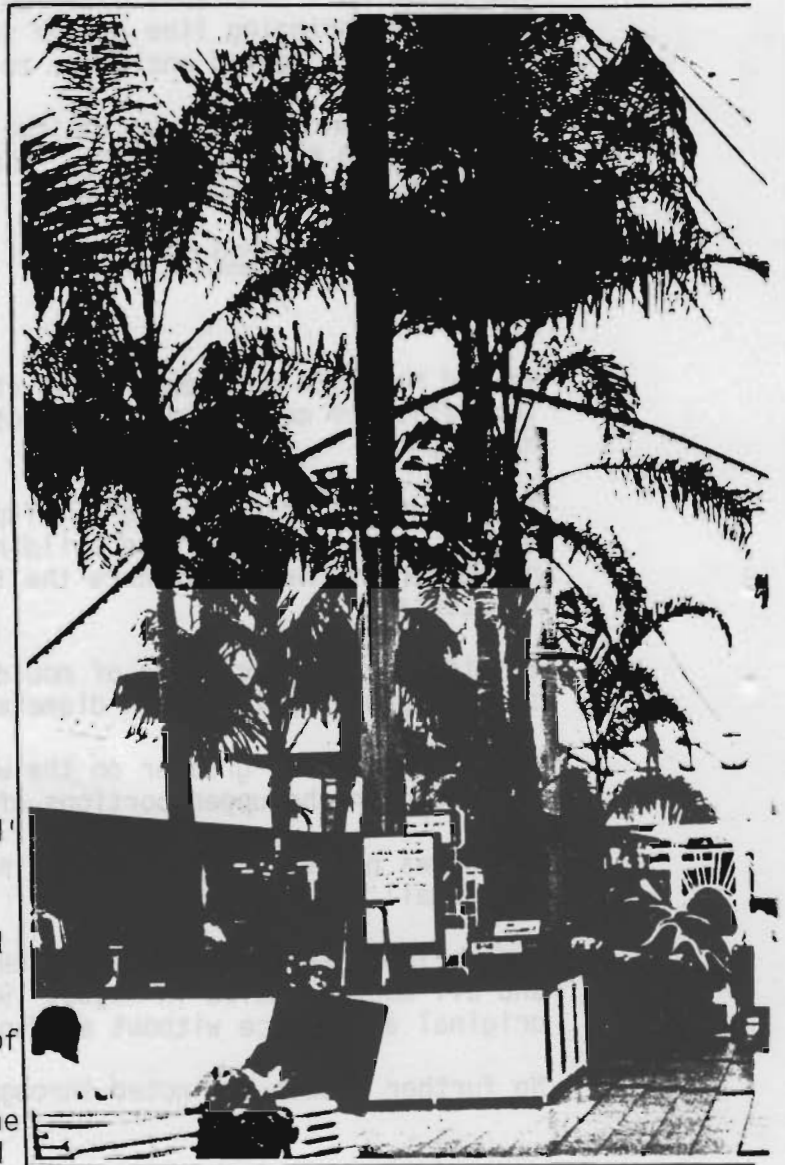
- . Palms were watered at random and had grown rapidly by 2m-3m. In some cases the fronds were in contact with the upper portion of the membrane.
- . The growth was most severe in the areas of the structure which did not dry quickly.

- . Conditions in the South Mall and Minor Mall differed as follows:
 1. No significant planting
 2. No internal gutter
 3. Roof sealed at the perimeter
 4. No fabric slope less than 30° except at the ridge
(The limited growth that occurred in the structures was at the ridge)

- . The mould was not generated by plant spores
- . A warm, moist environment was created in the Main Mall which caused the growth of mould.
- . Radiant heat captured by internal finishes during daytime was released at night and contained in the top $\frac{1}{2}$ of the cone structures
- . Moisture was added to the internal environment from the following sources:

Plant respiration
Casual water in gutter
Increased Humidity from winter rainfall
and morning mists

1. Top vents to be opened on winter evening to allow exhaust of stratified warm air
2. Internal gutters to be cleaned and as necessary replaced
3. Removal of 50% of palms and controlled watering of the remaining palms
4. Daily monitoring of effect vent operation on level of condensation to be undertaken for eighteen months (Fig. 2)
5. Two areas each 150mm x 150mm were left uncleaned. No condensation was detected from October 1987 to May 10, 1988.
